Figure 2-7
Mile 102 Montoya Arroyo

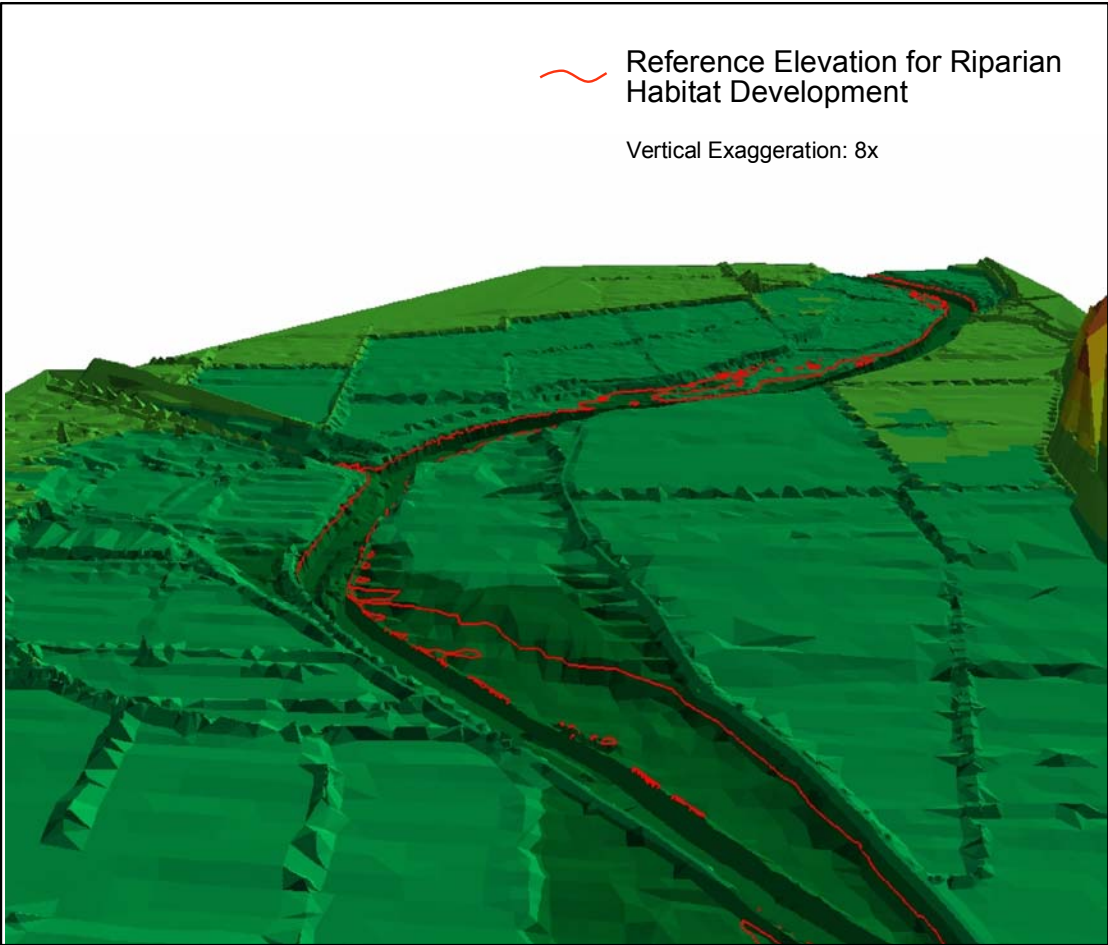
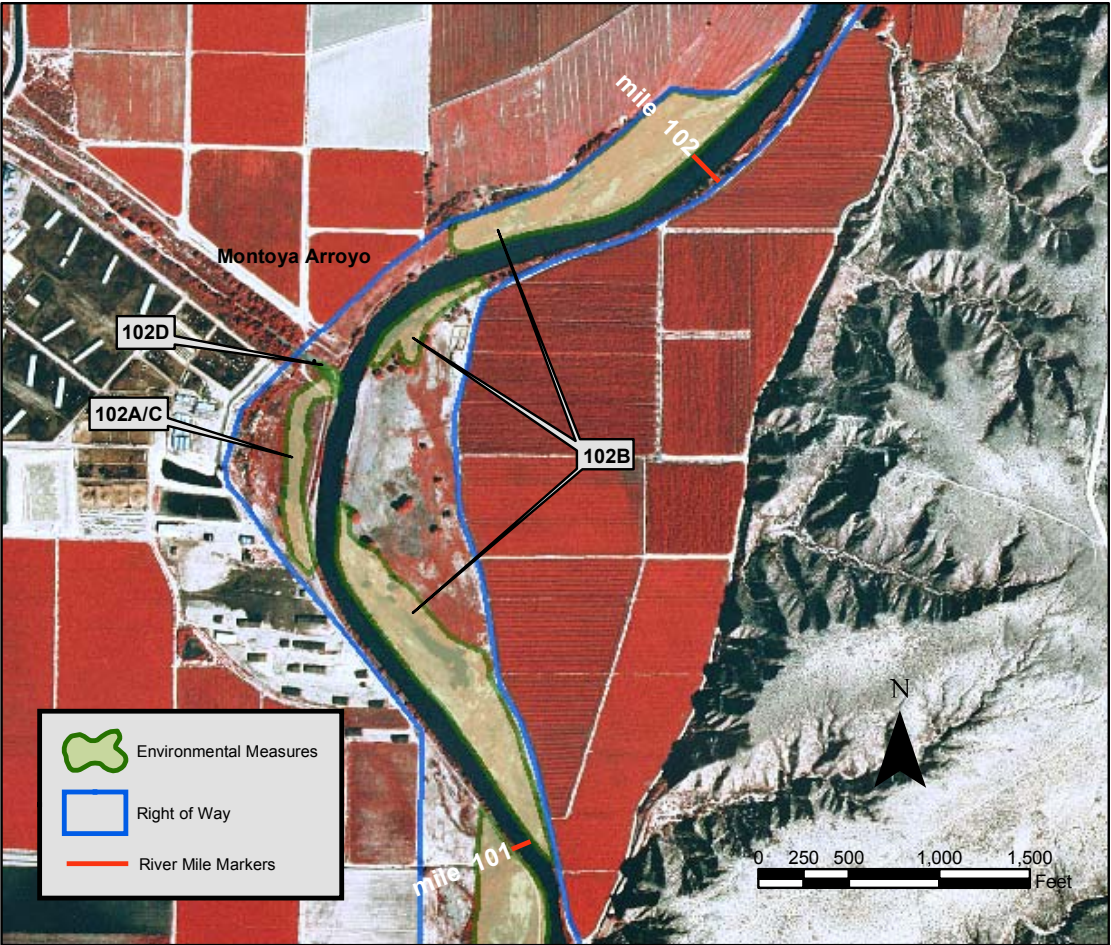
The mouth of Montoya Arroyo is on the western bank of the river at mile 101.5. The watershed covers 23 square miles and does not have a sediment control dam. The banks of the arroyo outside the ROW are heavily vegetated. This part of the ROW was originally a part of the river channel with an island separating two channels. The western channel was diked off and filled in during the RGCP construction.

Point Project Measures	ID	#	Area (ac)
Native vegetation planting	102A	1	2.8
Bank shave downs*	102B	3	24.7

Point Project Measures	ID	#	Area (ac)
Open former meanders	102C	1	2.8
Modify dredging at arroyos by creating embayments	103D	1	0.17
